524600 TANK-AF-F-10020 Survey of radioactivity and mercury, rev03

Contract Number: 4503 579 868
Project Title: ENGINEERING, PREPARATION, REMOVAL AND DISPOSAL OF THE 2/4 EKOFISK TANK TOPSIDES

Document Title:
Survey of radioactivity and mercury in the production lines on Ekofisk 2/4T

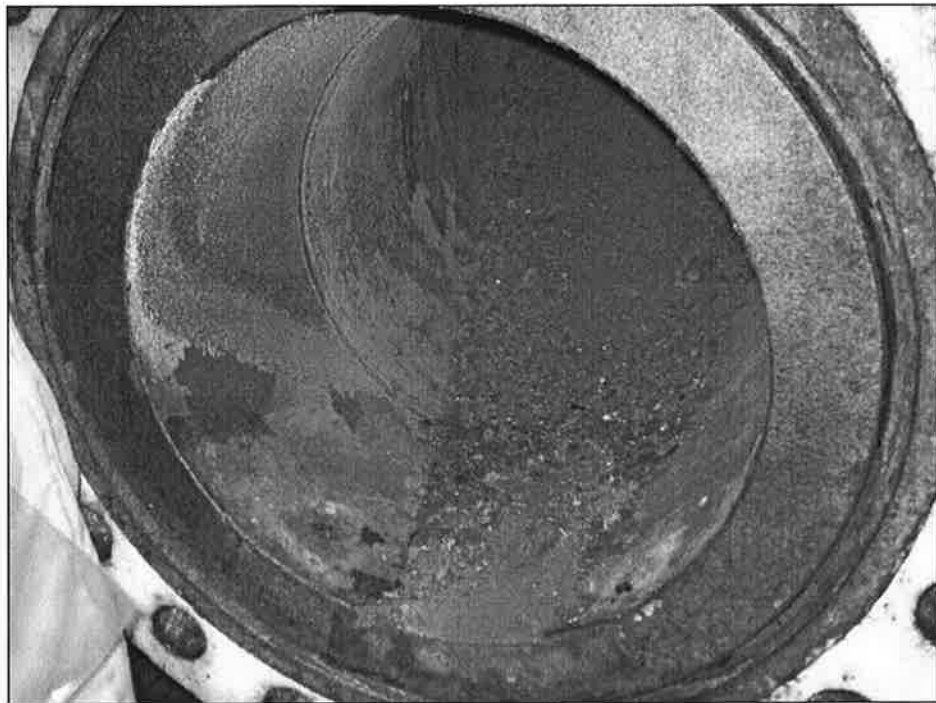
- i) Debris material – i.e. material easily sampled not strongly attached to the inner surface of the component. Typically this material was dispersed throughout the bottom of the samples components consisting of rust and debris sedimented within the equipment during the cleaning and flushing that was performed after shut-down (Fig. 1).

Fig. 1: Photo showing typical Debris material.

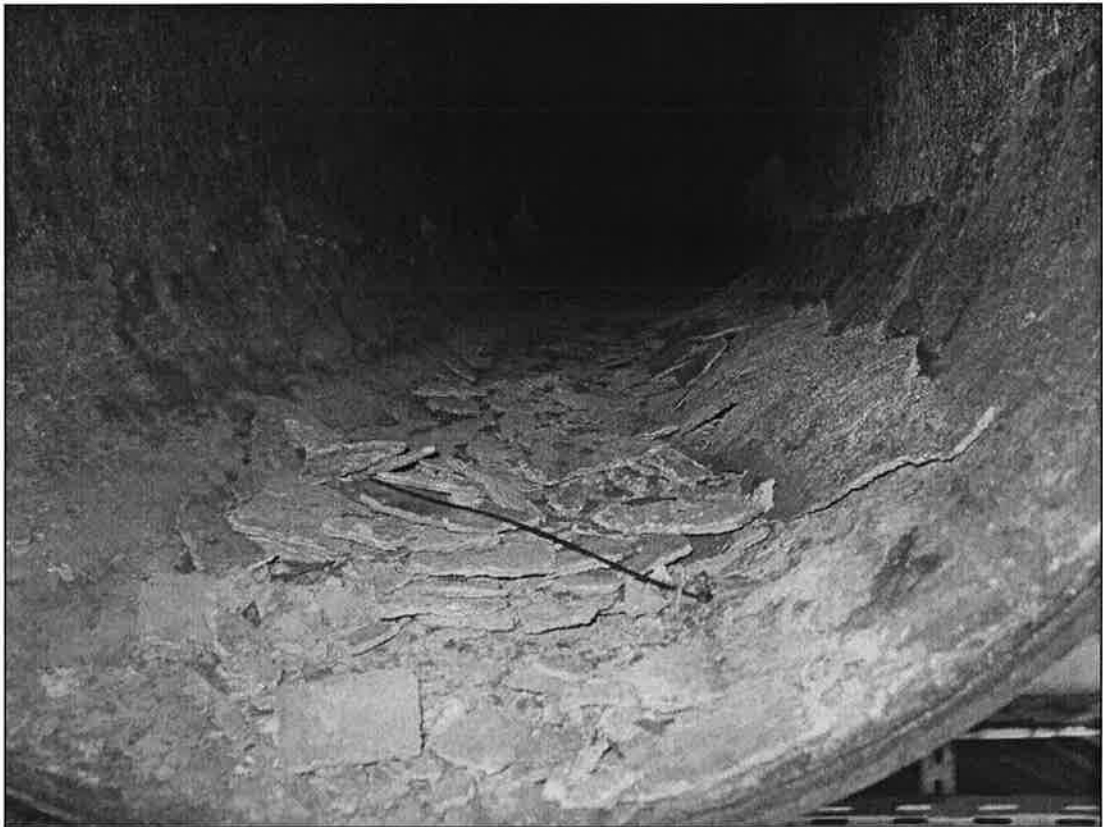
- Scale thickness and density: 5 – 10 mm and X.Y g/cm^3 , respectively.
- Abundance: $\frac{1}{4}$ of tube circumference (tube diameter 32”).
- Tube length: 100 m
- LSA Scale mass: 830 kg (8.3 kg/meter tube).

Fig. 4: Photo of LSA scale at the bottom of the oil export pipe on the Papa side.

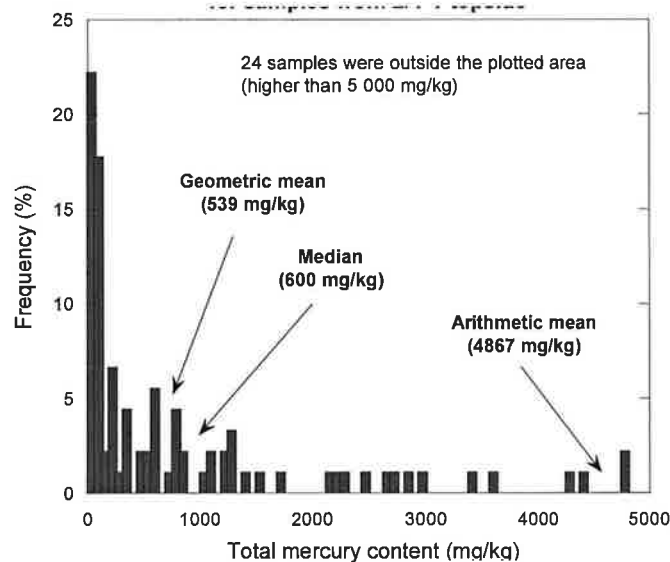
A frequency diagram showing the statistical distribution of the mercury content in the Debris samples are given in Fig. 5. The distribution shows the typical characteristics of a log-normal distribution with many extreme values. As the figure shows using the arithmetic mean as a mean value estimator would lead to a large overestimation of the "true" mean. For log-normal distributions the geometric mean is usually used as the mean value estimator. In this study, for the above-mentioned reasons, the geometric mean is used to represent the "mean value".

Fig. 5: Frequency diagram for total mercury content for 114 samples from 2/4T topside.

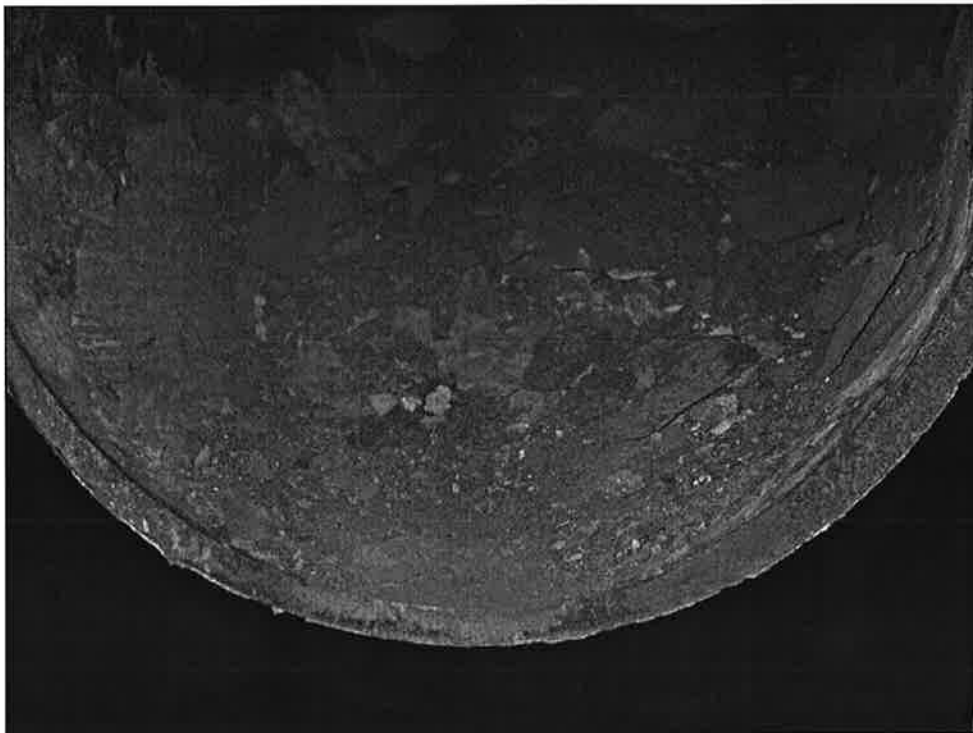
Fig. 9: Photo showing the scale flakes of corroded material at A-5. Note the black colour of the flakes.

The result is what is seen in Fig. 9: scale flakes of black coloured material mixed with ordinary rust. Black colour is typical for heavy metal sulphides, but black would also be the colour for solid materials coated with tar and wax.
