RF – Rogaland Research. <http://www.rf.no>

Assessment of environmental implications of mooring the Hutton TLP in Vatsfjorden

Report RF – 2002/191

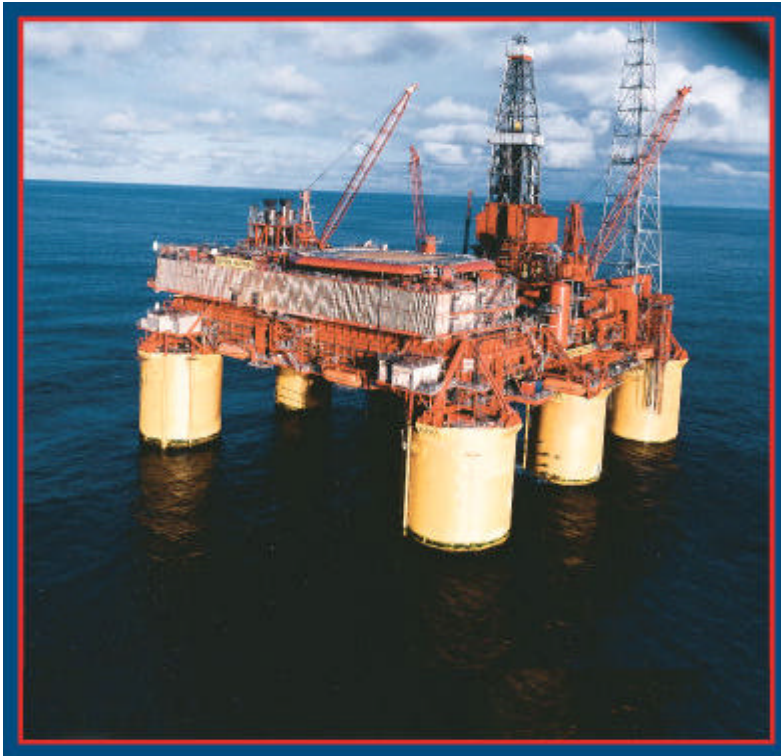
Figure 1. Illustration of Hutton TLP (from www.hutton-tlp.com)

The Hutton TLP is a semisubmersible platform with 6 columns, which has been operating at a water depth of 148m. The structure has an operating weight of 47,300 tonnes and each of the 6 columns is 65m high (Figure 1).

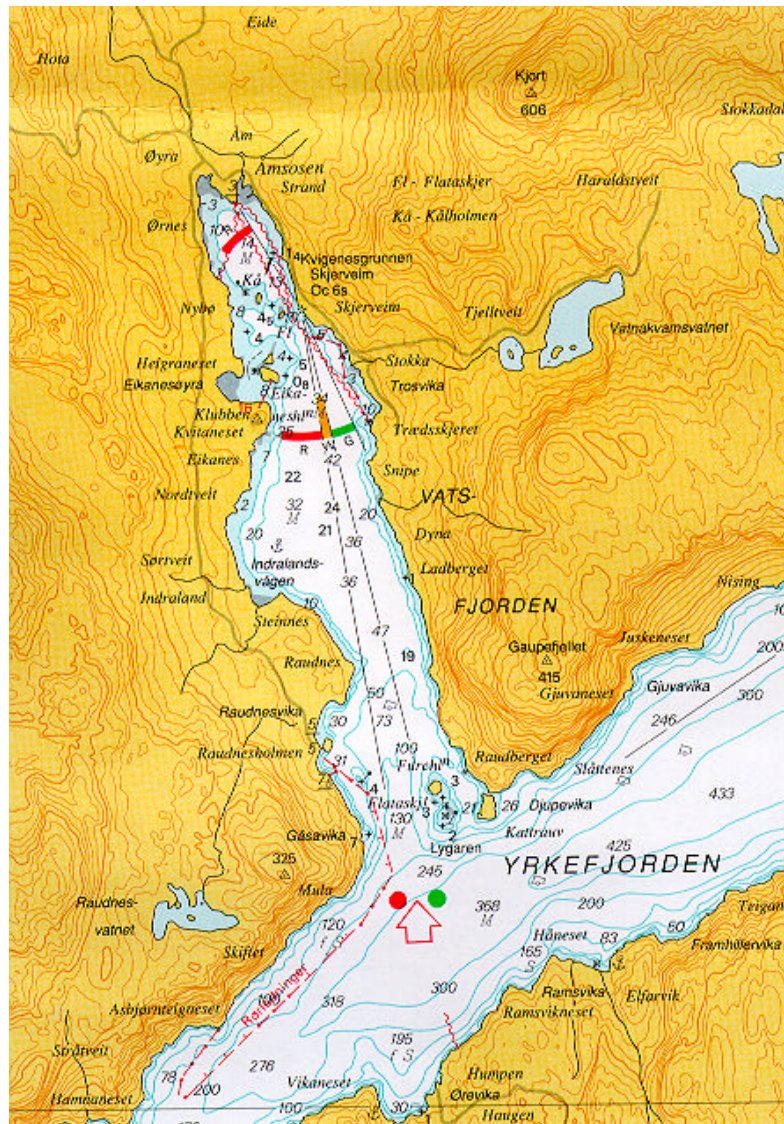
Figure 2. Map of Vatsfjorden and Yrkjefjorden

A map of Vatsfjorden is given in Figure 2. The mooring area is to the south of Raudnesholmen in the outer part of the fjord.

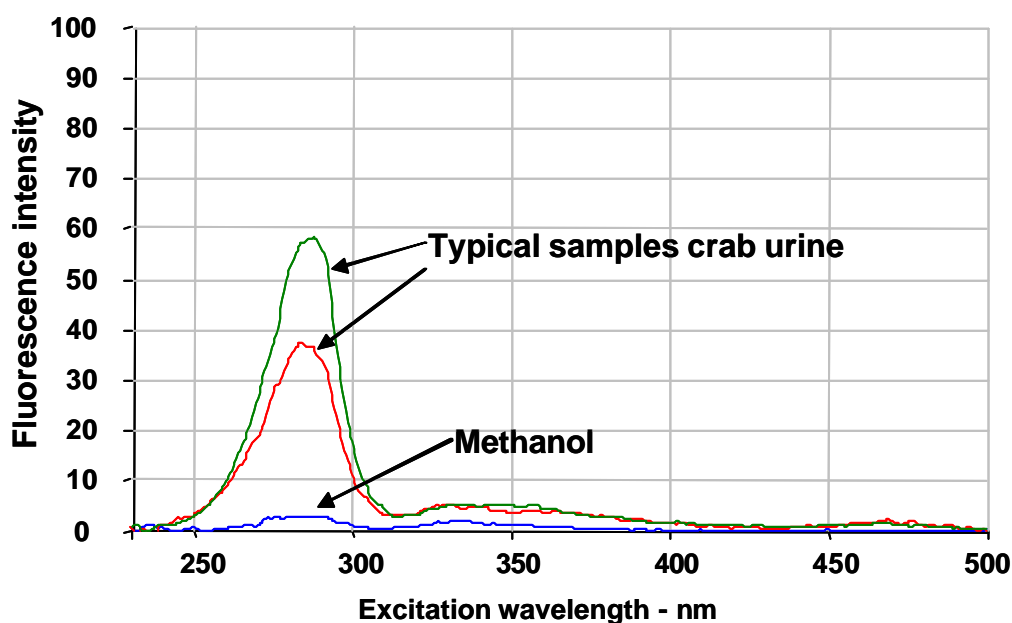
Figure 4. SFS-scan showing typical output from crab urine from unpolluted site.

Generally the results revealed fluorescence levels as could be expected from a clean site (Table 5). There are some fluorescence peaks around the 290/335 wavelength pair. The origin of this peak has also been detected in other expected clean sites, and it may be caused by natural constituents in the crab urine. A SFS-scan is shown in Figure 4.
