**Assessment of environmental implications
of mooring the Hutton TLP in Vatsfjorden**

Report RF – 2002/191

Project number: 715 16 64
Project title: Hutton TLP – GMC Marine
Project Quality Assurance: Øyvind F. Tvedten

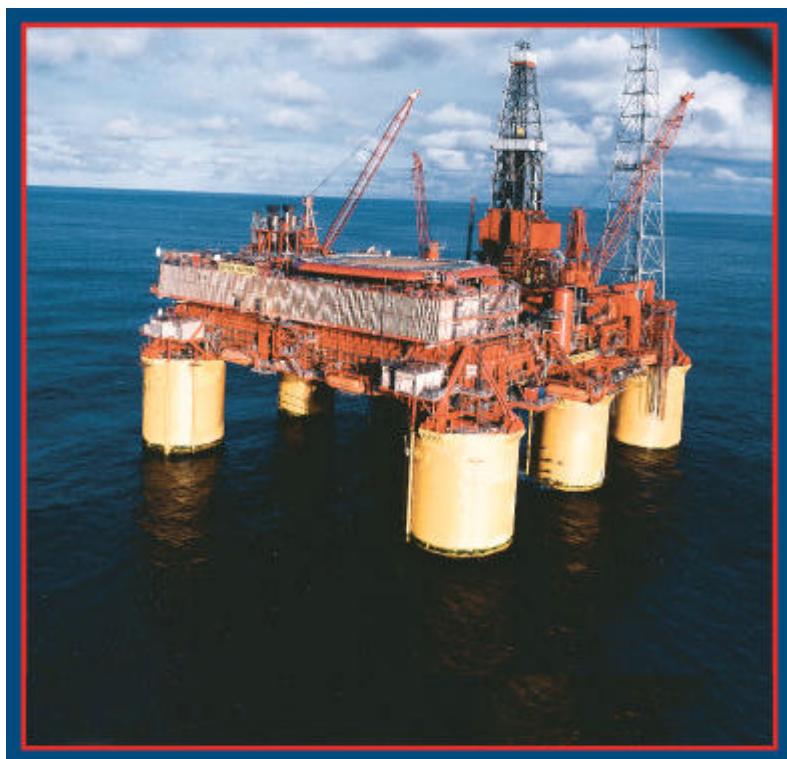
The Hutton TLP is a semisubmersible platform with 6 columns, which has been operating at a water depth of 148m. The structure has an operating weight of 47,300 tonnes and each of the 6 columns is 65m high (Figure 1).

Figure 1. Illustration of Hutton TLP (from www.hutton-tlp.com)

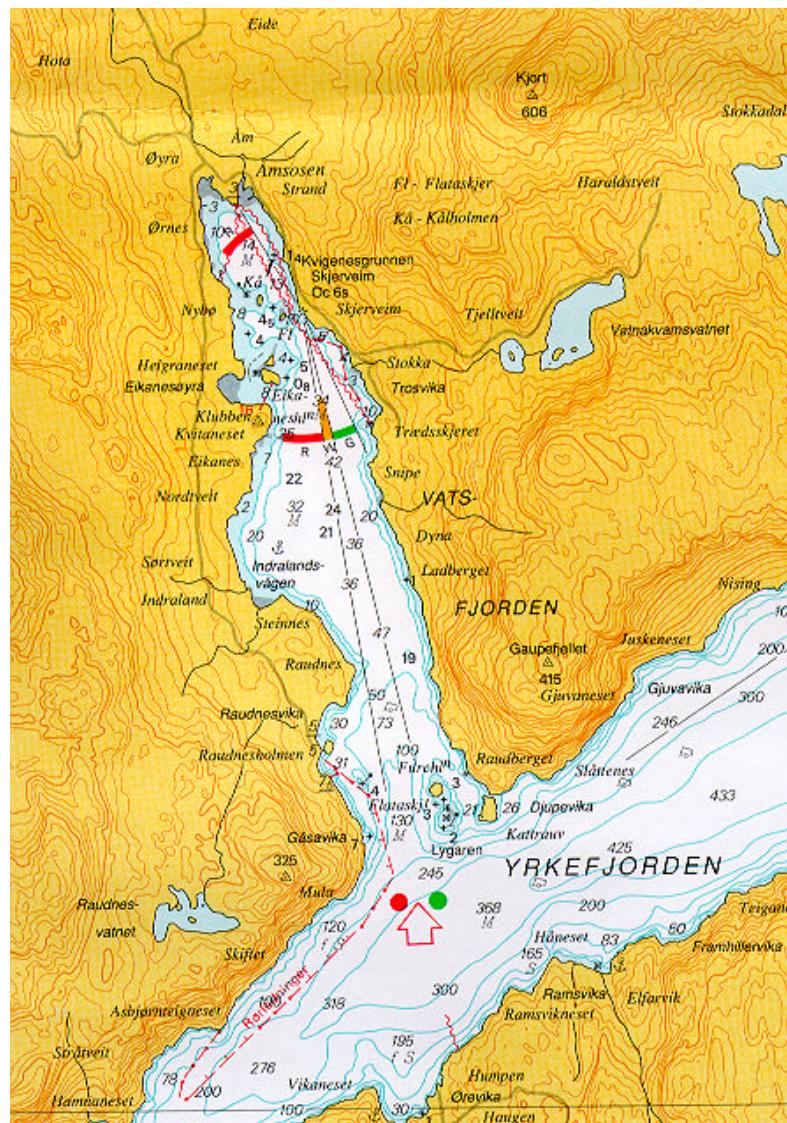
A map of Vatsfjorden is given in Figure 2. The mooring area is to the south of Raudnesholmen in the outer part of the fjord.

Figure 2. Map of Vatsfjorden and Yrkjefjorden.
